4. TITLE (and Subtitle) Phase I Inspection Report National Dam Safety Program Lake Arrowhead Dam Stafford County, State of Virginia		5. TYPE OF REPORT & PERIOD COVERED Final

NAME OF DAM: LAKE ARROWHEAD DAM

Name of Dam: Lake Arrowhead Dam
State: Virginia
County: Stafford
USGS 7.5 Minute Quadrangles: Storck, VA and Somerville, VA
Stream: Unnamed Tributary to Aquia Creek
Date of Inspection: 17 April 1980

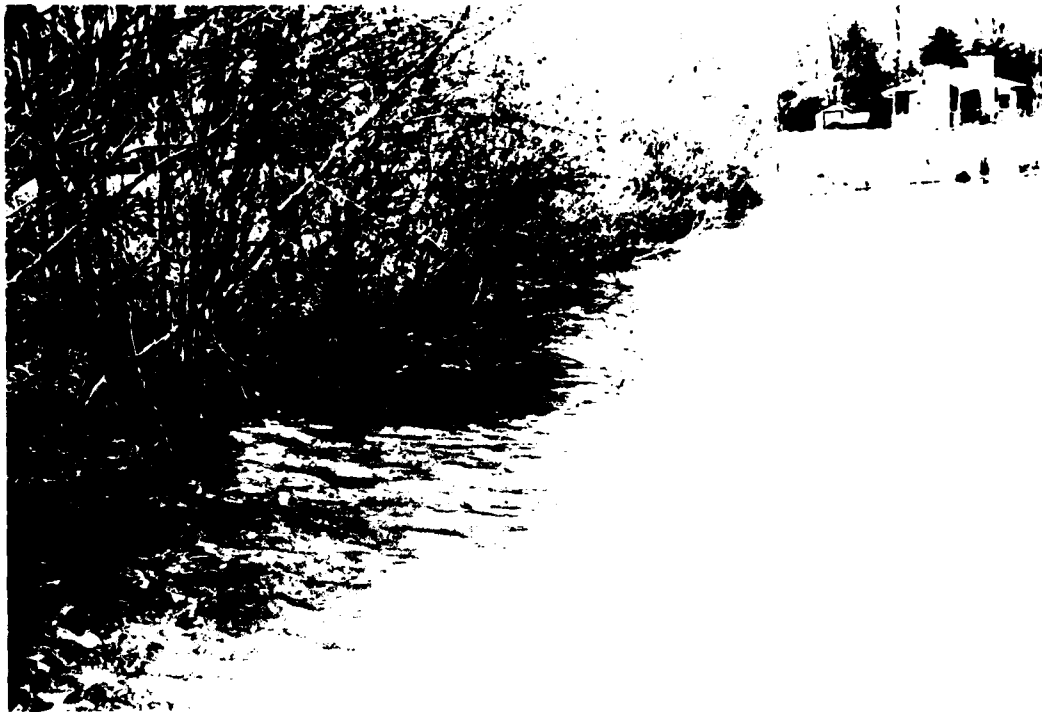
3.1.2 Dam: The embankment was found to be in generally fair condition with no surface cracks or sloughs. The surface of the downstream slope is fairly uneven. Minor erosion has occurred on the upstream slope along the waterline and in an area where a fire hydrant with a line into the lake has been installed. The upstream slope is covered with brush and small trees; the downstream slope is covered with brush and small-to-medium size trees.

PHOTO 1. Upstream Slope (Emergency spillway approach channel at far right)

approach channel should be reconstructed and better defined. The erosion on the upstream embankment slope should be repaired and riprap should be installed near the waterline. A good grass cover should be established over the entire embankment and in the emergency spillway approach channel. The tree stumps, logs, and other debris in the emergency spillway discharge channel should be removed. The entire discharge channel should be widened, regraded, and provided with erosion protection. Grouted riprap may be necessary. A trash rack should be installed on the principal spillway riser. The driftwood in the pool below the principal spillway outlet structure should be removed, as should the vegetation overhanging the pool. A staff gage should be installed to monitor reservoir levels above normal pool.
